[Please copy in the student work – Excellence]

Findings/Conclusion, Part 1

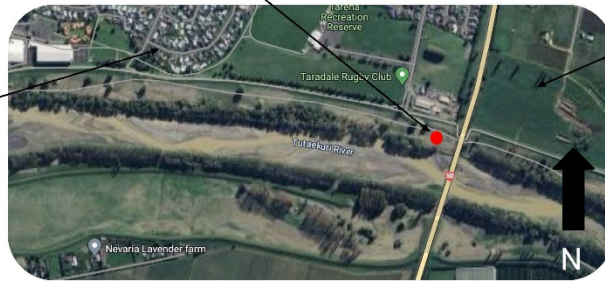
Figure 5 - Tūtaekurī river, Guppy Road

This area of the Tūtaekurī river, is very populated and surrounded by houses and infrastructure, displaying the area is urbanized and developed. This indicates many negative consequences such as water quality degradation of this area of the river. Runoff from roofs and roads during rainfall may contaminate the river, as this runoff often contains heavy metals, oils and fertilizers. Overall, urbanization may lead to loss of natural habitats along the river.

As I have mentioned, this area around the Tūtaekurī is a bustling community, and this includes paddocks and livestock. This may contribute to both negative and positive impacts on the river. For example, positively, the livestock may help naturally fertilize the soil, making riverbanks and plants healthy. However, if this is uncontrolled, too much livestock manure may lead to pollution of the river, affecting many areas such as water clarity and aroma

Tūtaekurī river runs through many urbanized areas, which could contribute to both positive and negative consequences of the river. It's a notably well-used river for swimming, and is often used for many recreational activities such as canoeing and kayaking.

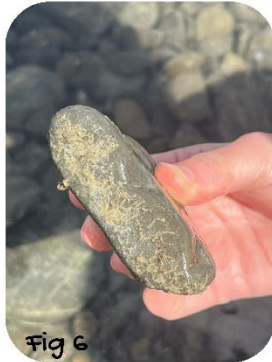
Fig 6

In the Tukituki river, a thin to medium film or mat is observed, mainly on the top part of the rocks, gently coating the riverbed. We discovered that the further you went out into the river, the thicker the Algae became.

Location: Red Bridge
River: Tukituki

Furthermore, algae had an interesting effect on both rivers and there was a diverse range of algae presented at the rivers. The Tukituki, as shown in figure 6 and 7, displayed a thin to medium layer on the riverbed. However, the Tūtaekuri river demonstrated stringy, thick mats of algae attached to its river bed, as you can see from figures 8-9. Long filaments like the ones found in the Tūtaekuri river indicate that there is a high enrichment of phosphate and/or nitrogen (conductivity). The conductivity score on the Tūtaekuri river was 370, demonstrating the factors are true as this score is particularly high for a river. Nutrient-rich awa provides an environment for a robust ecosystem to flourish, making the awa a common home for critters. The potential thriving ecosystem reflects interconnectedness with Te Taiao, where the health of the river is connected to the ecosystems living amongst it and providing a healthy awa for growth. In comparison, the Tukituki river delivered a different algae profile. This may indicate lower nutrient levels in the water, influenced by elements such as agricultural runoff, potentially affected by Cyclone Gabrielle. The two destinations of the Tukituki river give a combined average of 221 for conductivity, which is relatively low. A total Nitrogen 2022 - early 2023 graph presented from secondary data* illustrates a trend that is likely decreasing and states it's in the 'worst 50% of all sites'. The graph shows a decreasing trend near the end of the year from October - December, indicating the conductivity has been recently worsened, overall contributing to the state of the algae.

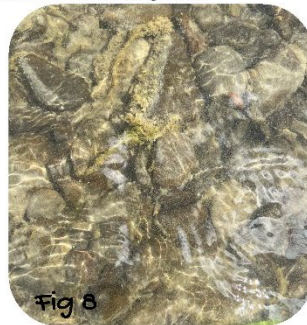
Fig 8

In comparison to the Tukituki, the Tūtaekurī presented stringy, thick mats of Algae clinging to rocks and floating across the river.

The differing Algae formations the two rivers have to offer link to Mauri: the Tūtaekurī algae suggests a delicate balance and positive quality of the water, whereas the Tukituki algae suggests a potential imbalance or stress within the water.
